Three Seasons of Applying Physical Methods to Control Hydrilla in Mystic Lake on Cape Cod

Bob Nichols
Indian Ponds Association
www.indianponds.org

Mystic Lake – Barnstable, MA

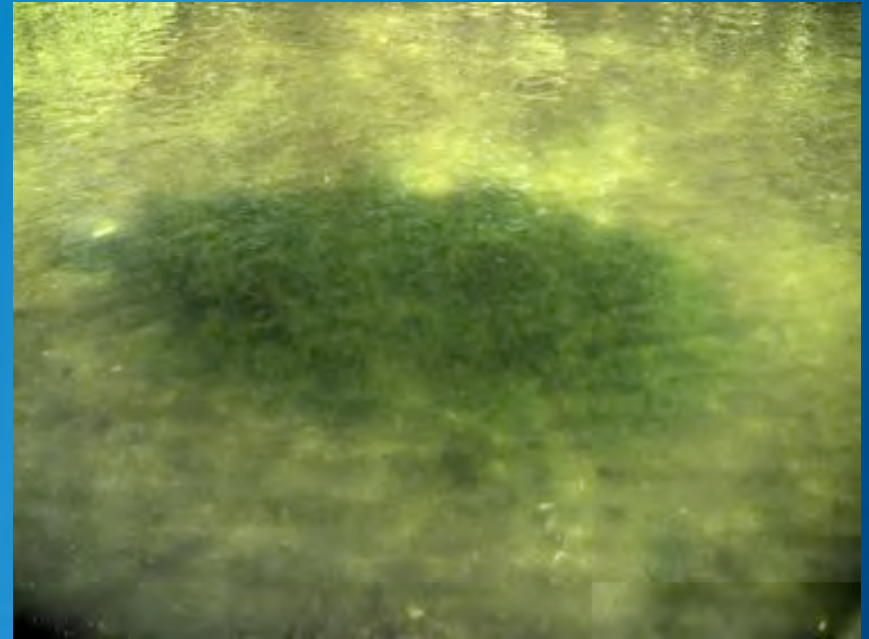
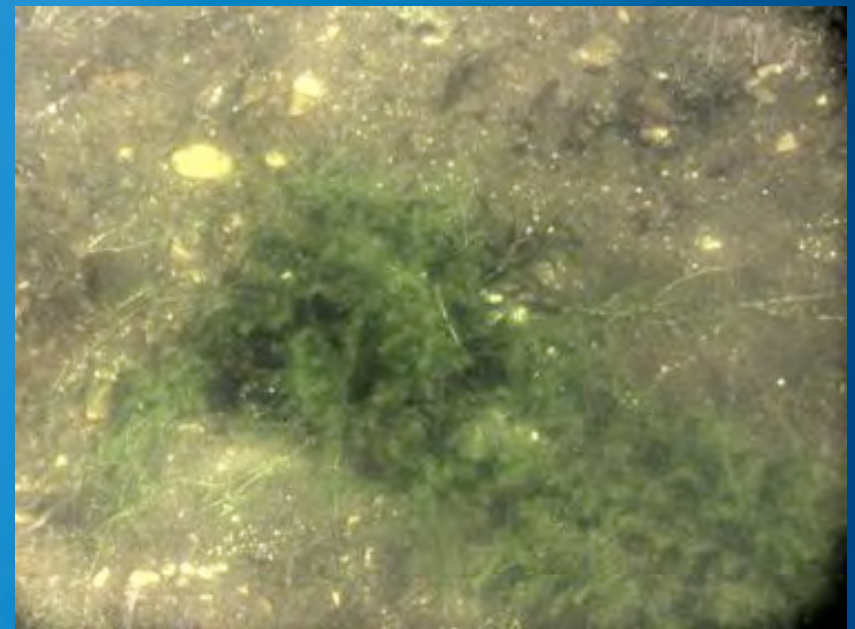
Hydrilla Patches Easily Found

- 2-9 ft diameter, dense, bright green patches easily spotted in calm conditions by boat survey
- All in 2-5 ft water depth
- None had topped out at surface

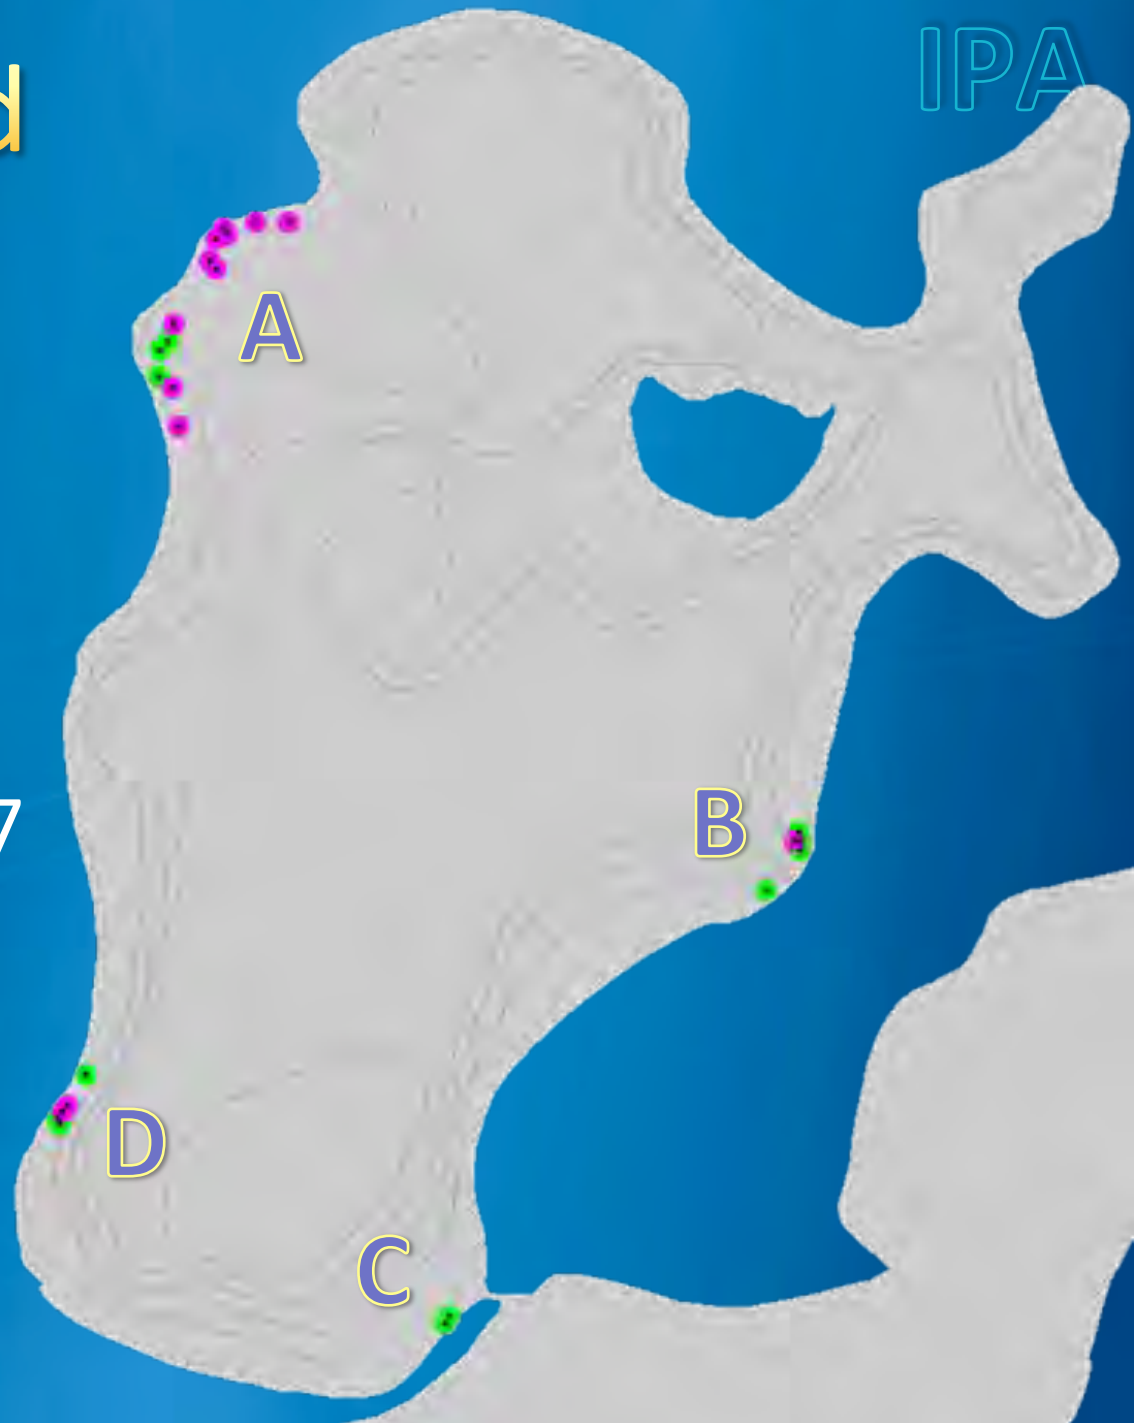
Hydrilla Spread in 2011

- New patches (purple dots) discovered in 3 of the 4 areas
- Deepest patch in 7 ft of water
- New plants found in all 4 areas
- No new areas found

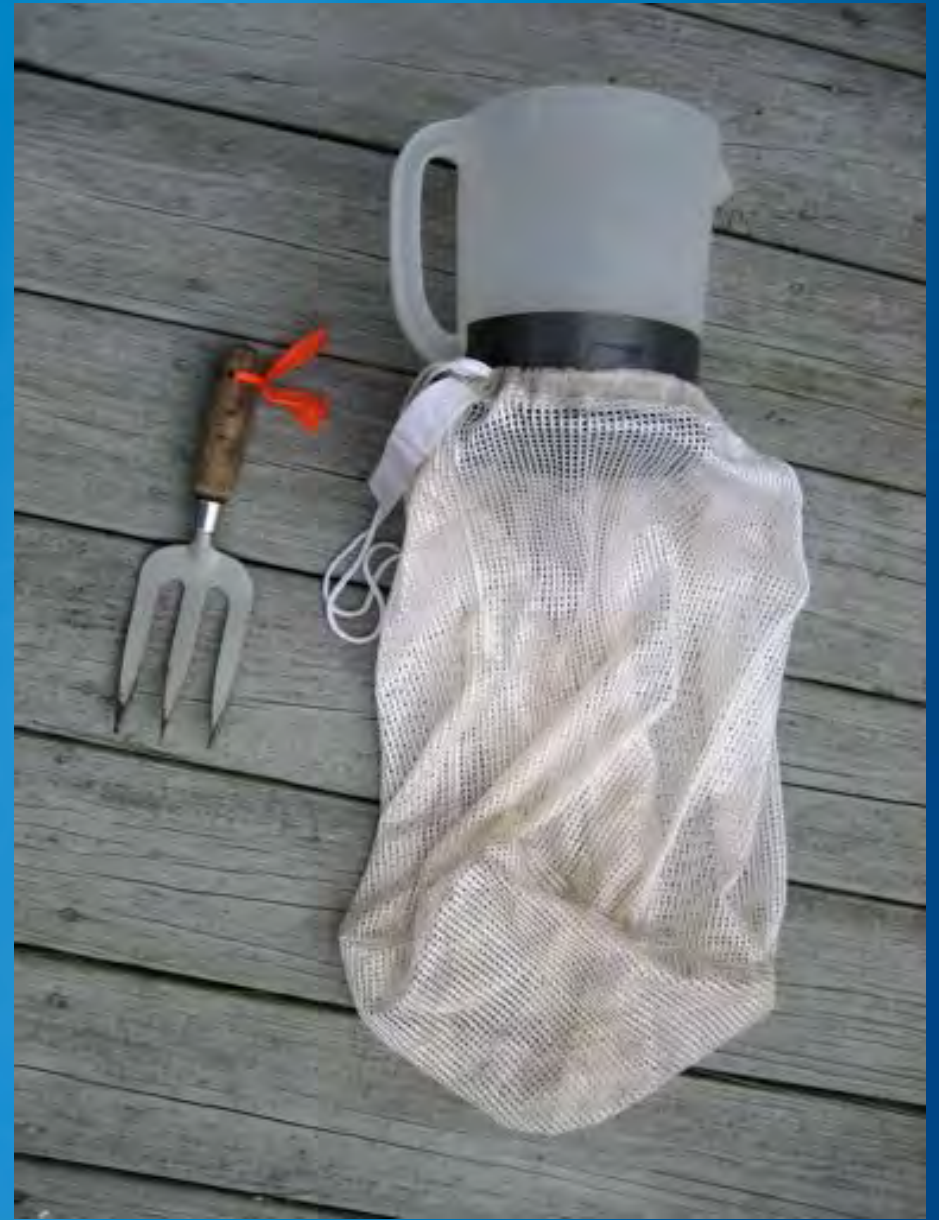
Tools We Use for Hand Pulling

- Plastic pitcher with bottom cut-off
 - Heavy rope duct taped above cut edge
 - Fine mesh laundry bag cinched over rope lip
- Can sweep pitcher to easily capture loose fragments
- Hand fork to loosen plant roots

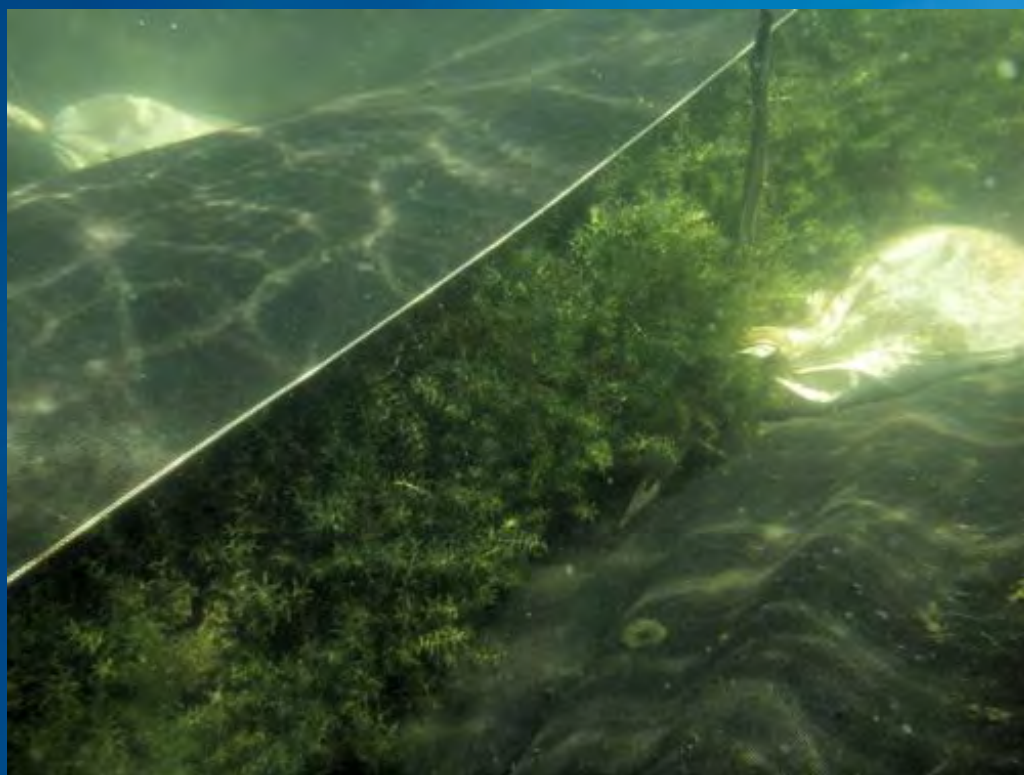
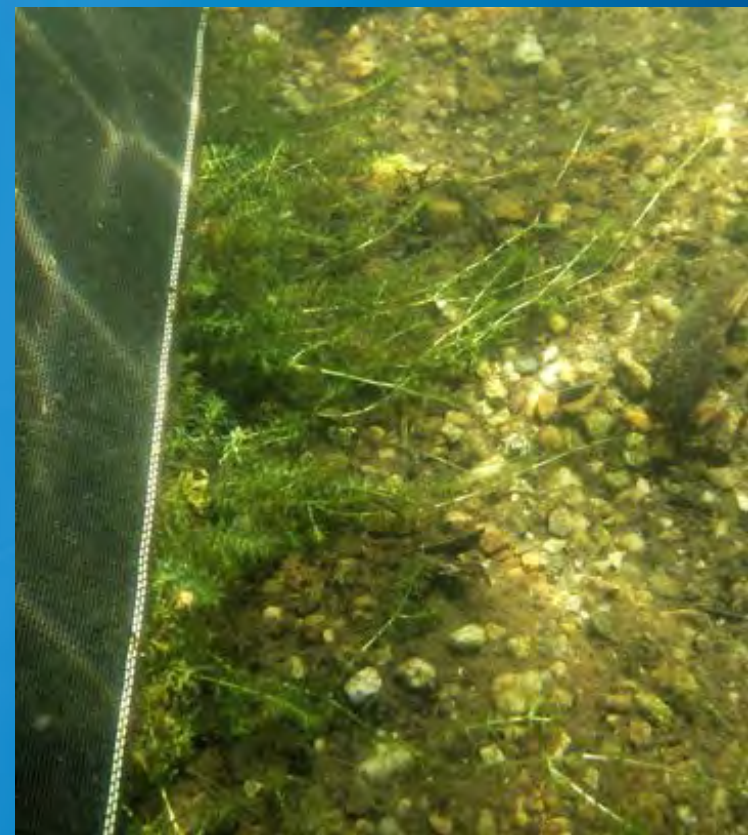
AquaScreen Benthic Barriers

- 2010 - deployed barriers areas raking out patches
- Left in place to mid 2012

- Little or no regrowth under all, except vigorous regrowth at large original patch

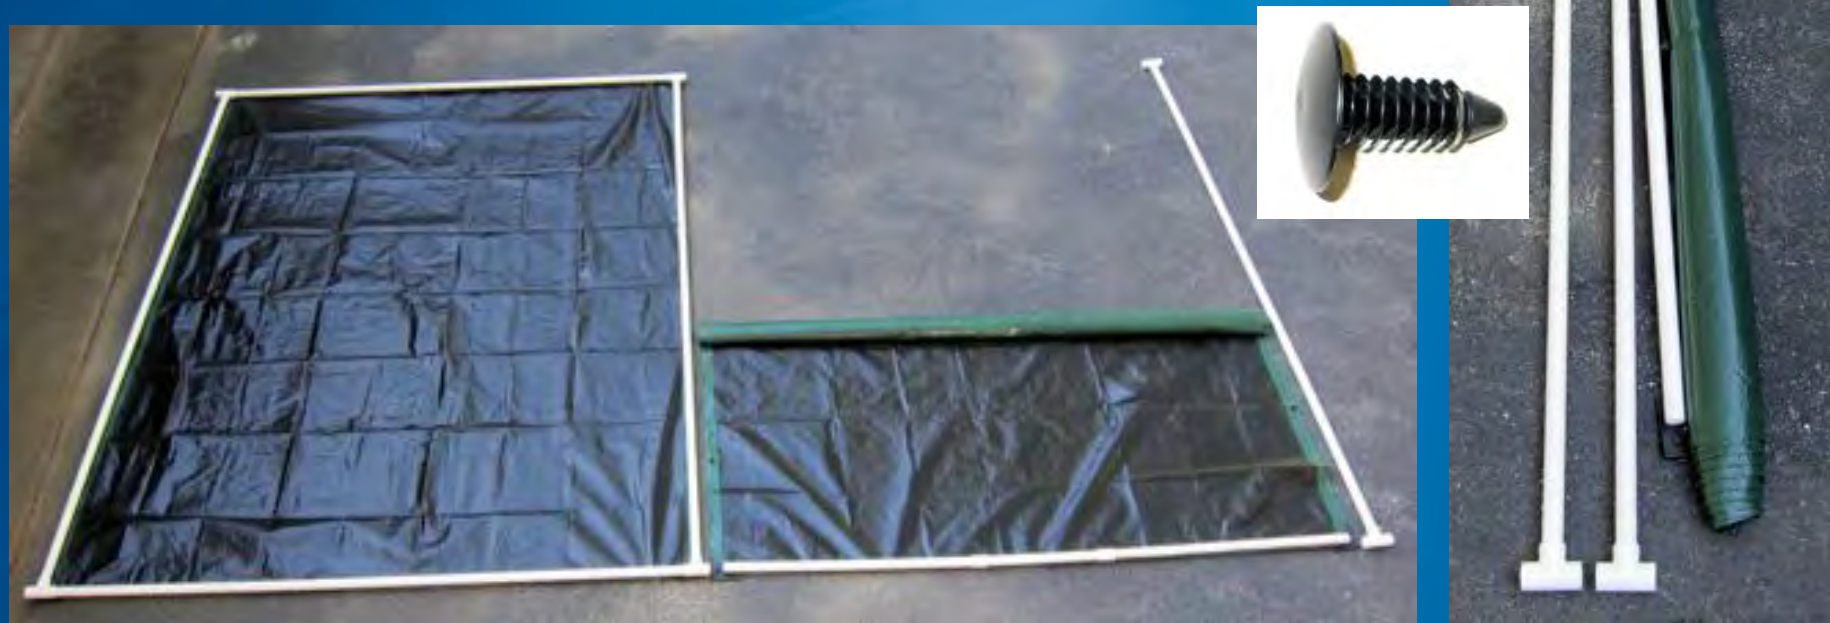
Opaque Benthic Barriers

- 2012 deployed opaque tarp barriers, kills Hydrilla patches in 50-60 days
- Tarps framed with 1 inch PVC pipe
- Tees allow easy joining of panels
- Roll for easy transport/deployment

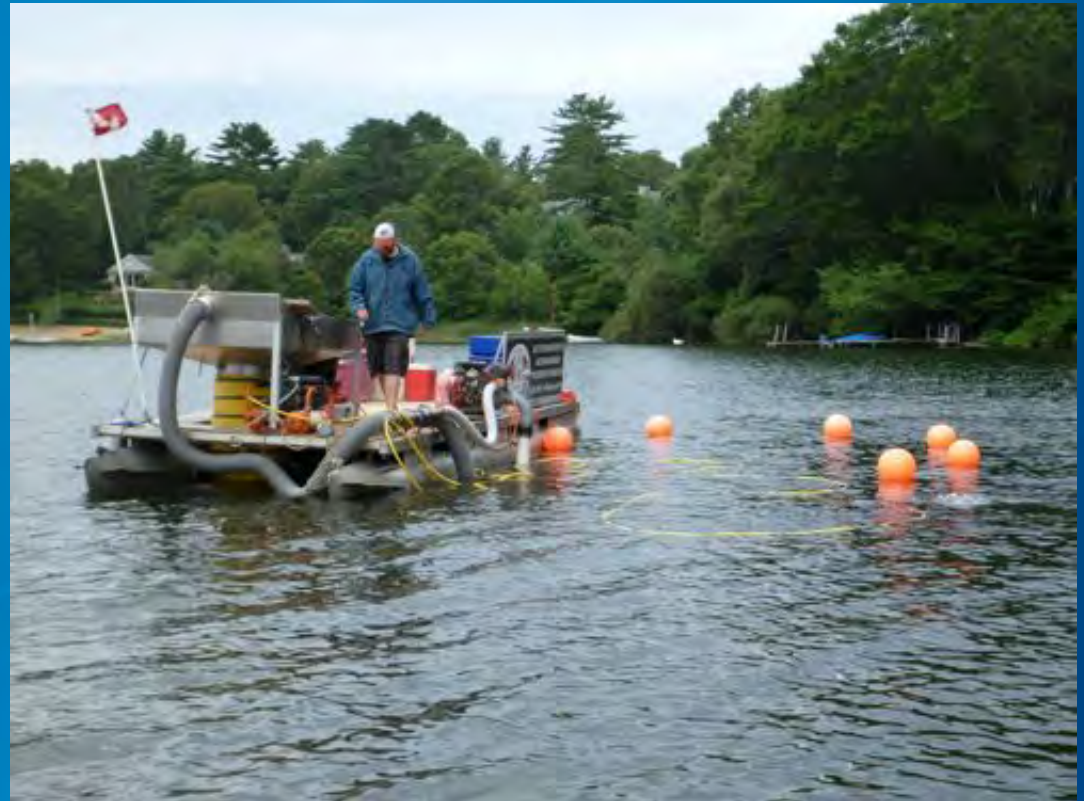
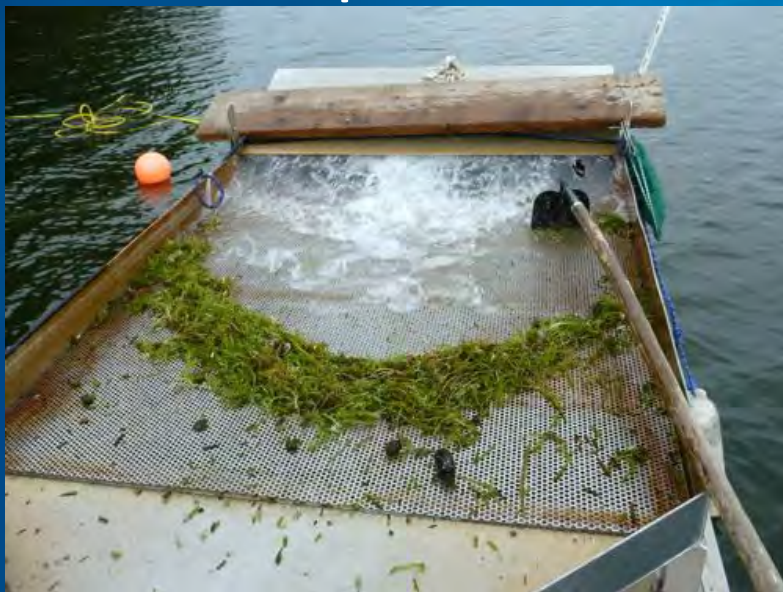
Diver Assisted Suction Harvesting

- Spoils discharged on perforated tray
- Water, sediment returned thru duct to bottom
- Plants put in tubs

- Operator tosses back live crayfish, mussels, snails
- Very few escaping plant fragments

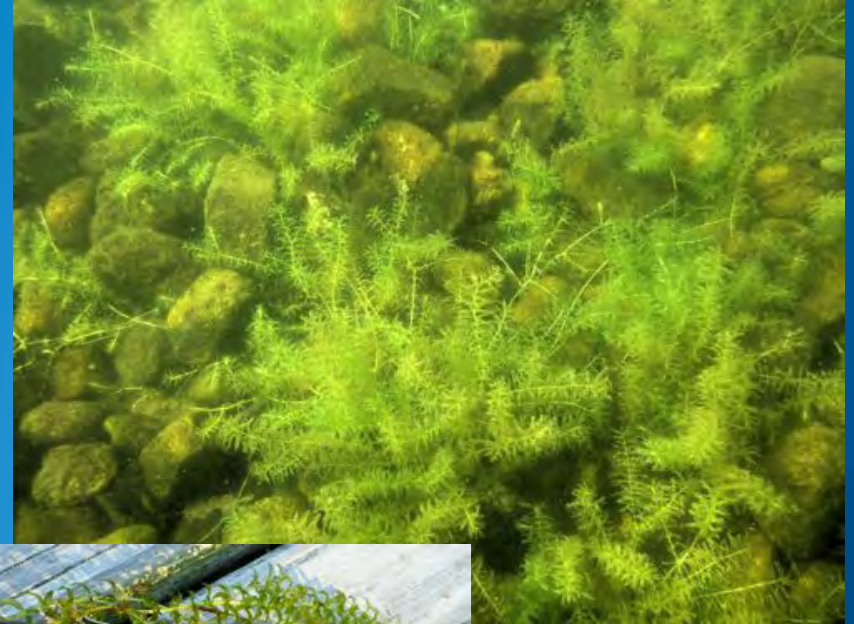
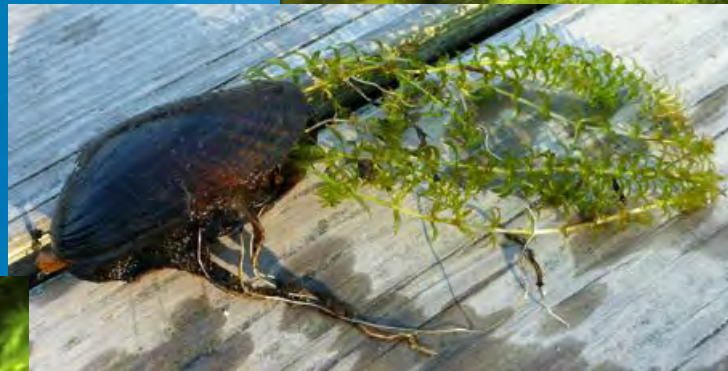
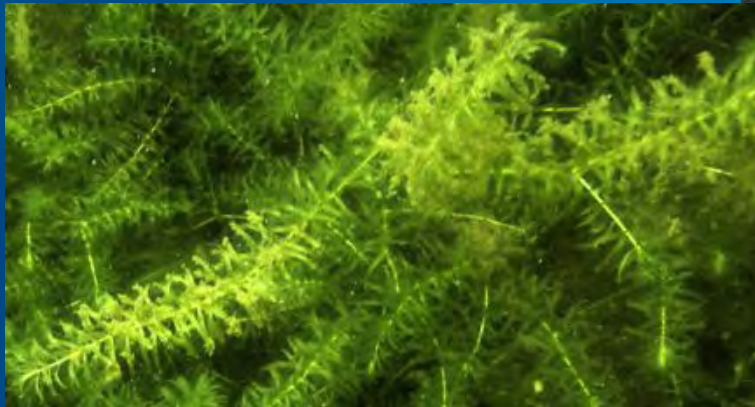
Hydrilla Field Observations

- Will root and grow in almost any substrate
- Found in depths 1-8 ft, but typically 2-5 ft
- Often found rooted in dead mussels

- Blue-green algae (possibly Microcoleus) found on it, apparently inhibiting growth

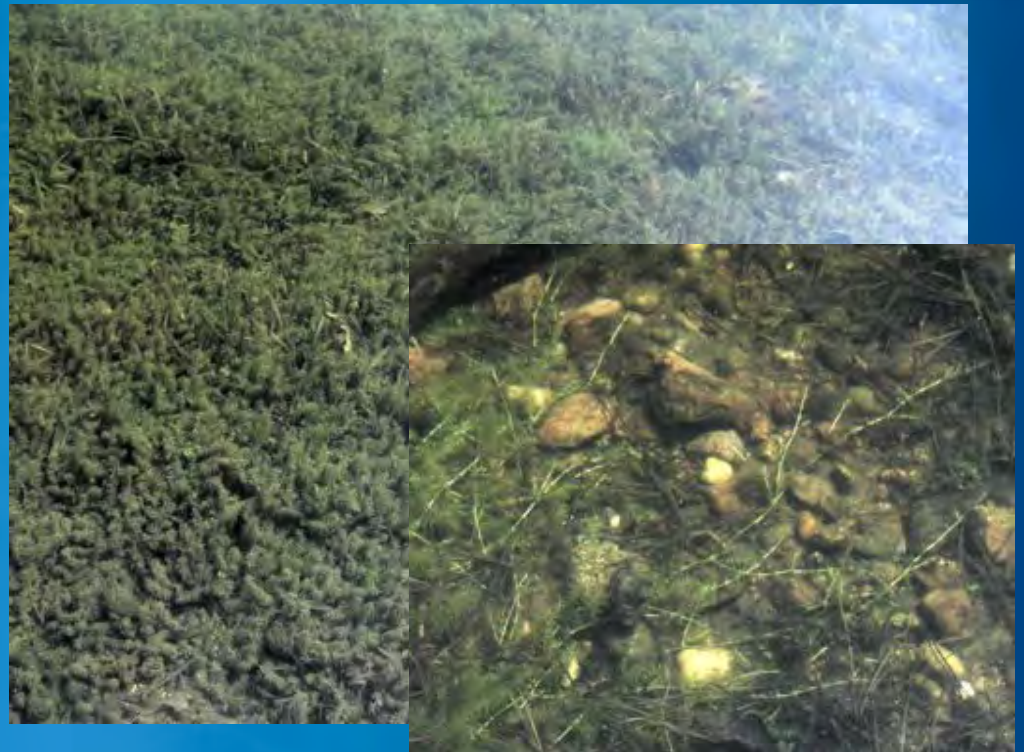
Growth Pattern and Water Clarity IPA

- More light more vigorous horizontal expansion
- 2010 poor water clarity (1-2m Secchi):
 - 6 ft diameter patch, 3 ft tall, in 4 ft of water
 - 9 ft diameter patch, 1 ft tall, in 2 ft of water
- 2012 (3-5m Secchi)
 - Aug 3 - no sign of Hydrilla at a spot
 - Sept 16 – same spot: dense patch 8 ft diam, <6 inches tall, in 2 ft of water, expanding rapidly

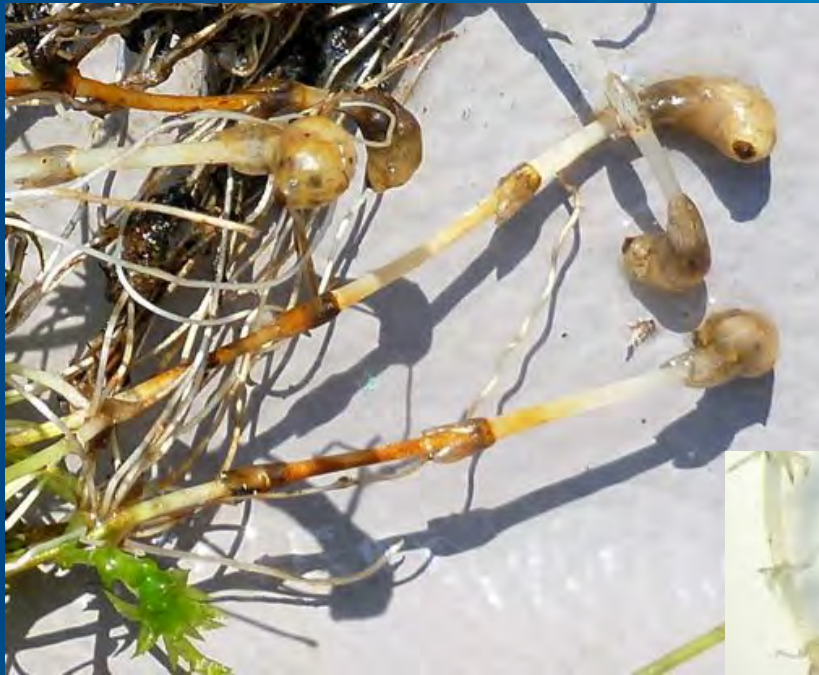
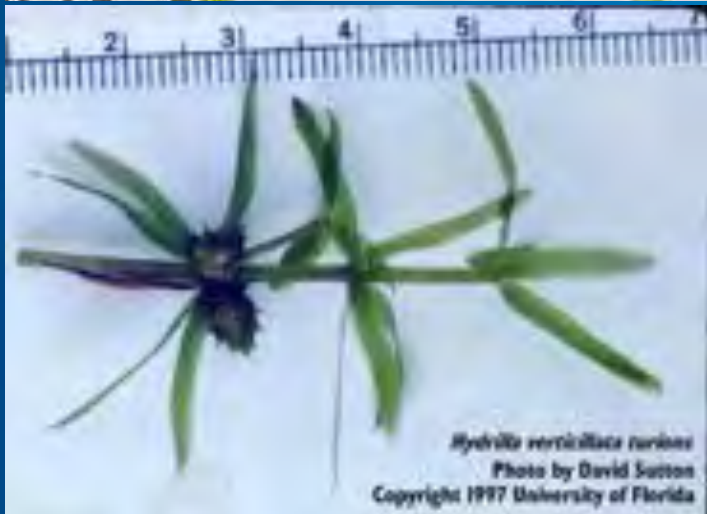
Hydrilla Tubers and Turions

- Only sprouted tubers (at left) found June – Aug
- New formed tubers (below) in mid Sept

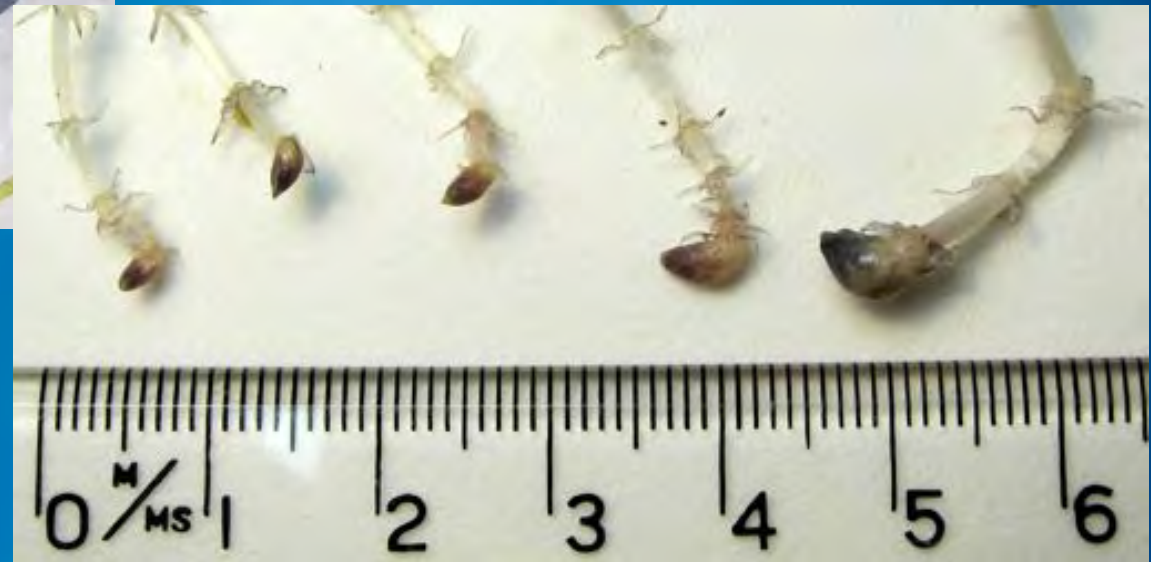
Hydrilla verticillata turion
 Photo by David Sutton
 Copyright 1997 University of Florida

- Never found turions (at left)

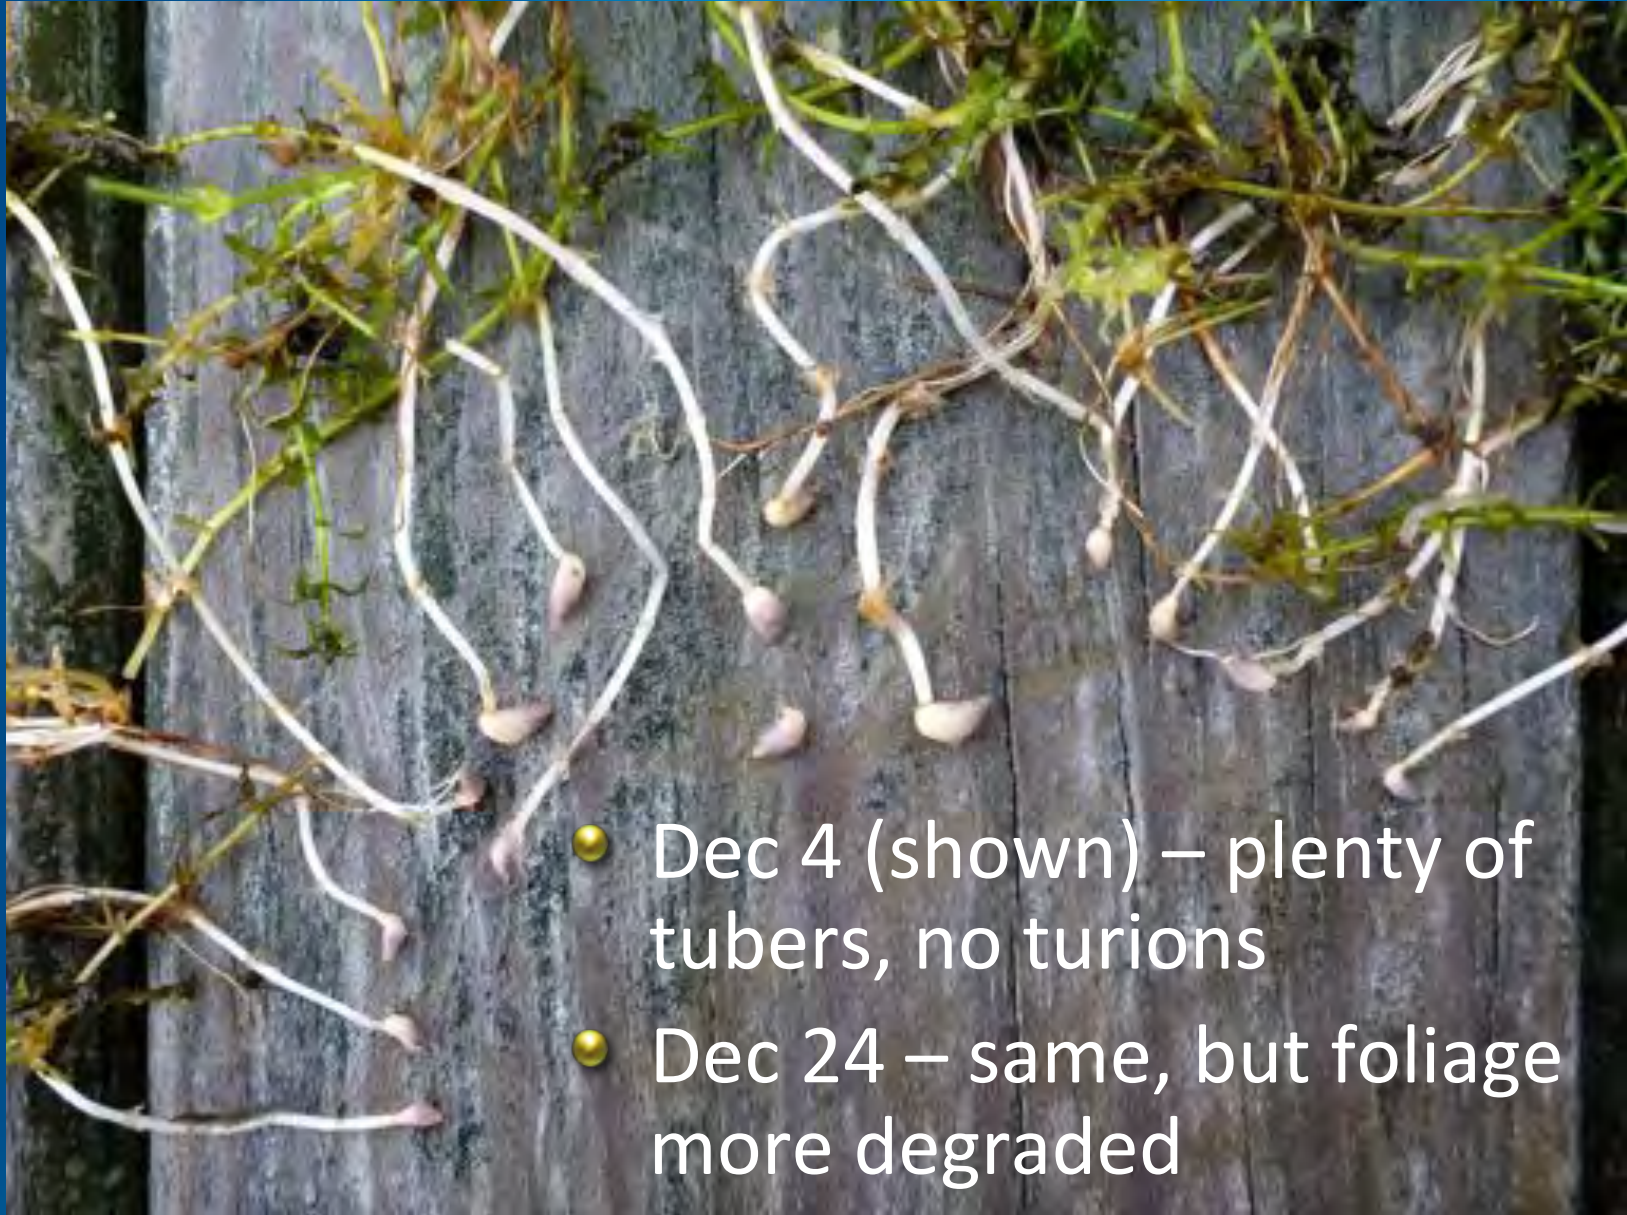
Late Season Rake Samples

- Dec 4 (shown) – plenty of tubers, no turions
- Dec 24 – same, but foliage more degraded

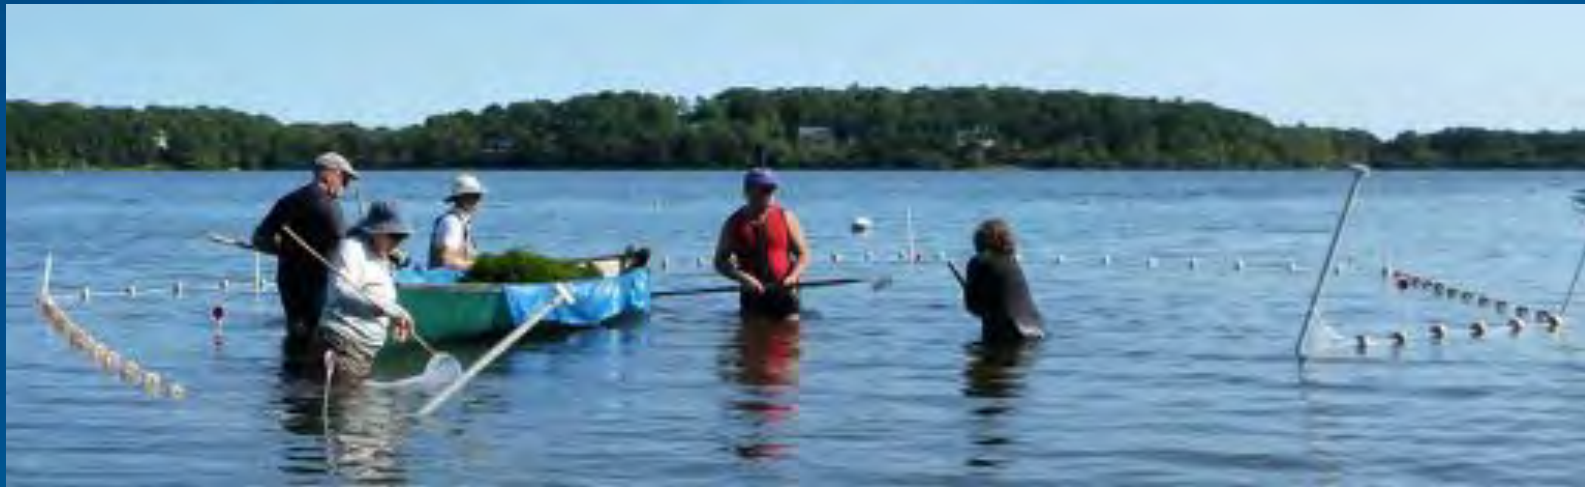
Age of Patch Controls Success

- Good chance of elimination if tubers not formed
 - single plant or patch started from fragment and pulled or killed by end of August
- Pioneer 30ft x 40ft patch raked out again in 2012 after sprouting under AquaScreen barrier
 - 4 inch diameter sediment core sample showed 3 sprouted and 2 dormant tubers
